**MARYLAND HISTORICAL TRUST
DETERMINATION OF ELIGIBILITY FORM**

Property Name: SHA Bridge 0303400, US 40 Little Gunpowder Falls Inventory Number: BA-2665
Address: Pulaski Highway (US 40) New Philadelphia Road Historic district: ☐ yes ☒ no
City: Joppatown Zip Code: 21085 County: Baltimore County
USGS Quadrangle(s): ~~Bel Air~~ EDGEWOOD
Property Owner: State Highway Administration Tax Account ID Number: _____
Tax Map Parcel Number(s): _____ Tax Map Number: _____
Project: Reevaluation of Highway Bridges Statewide Agency: FHWA/MD SHA
Agency Prepared By: KCI Technologies, Inc.
Preparer's Name: Alison Ross Date Prepared: 10/16/2009
Documentation is presented in: Project Review and Compliance Files
Preparer's Eligibility Recommendation: ☐ Eligibility recommended ☒ Eligibility not recommended
Criteria: ☐ A ☐ B ☐ C ☐ D Considerations: ☐ A ☐ B ☐ C ☐ D ☐ E ☐ F ☐ G
Complete if the property is a contributing or non-contributing resource to a NR district/property
Name of the District/Property: _____

MIHP No. BA-2665
SHA Bridge No. 0303400
US 40 over Little Gunpowder Falls
Baltimore County, Maryland

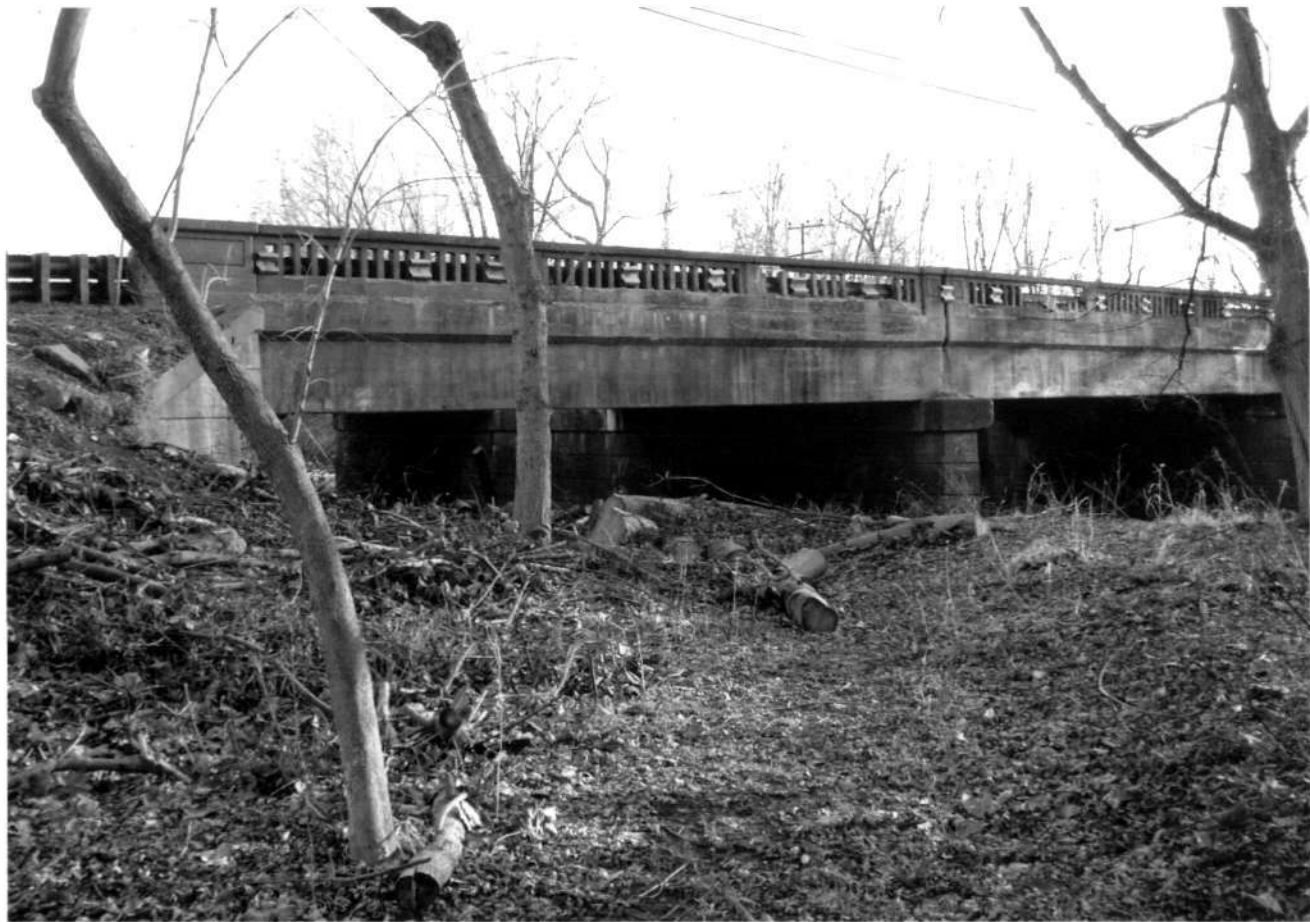
#1 of 6

NW elev., facing SE

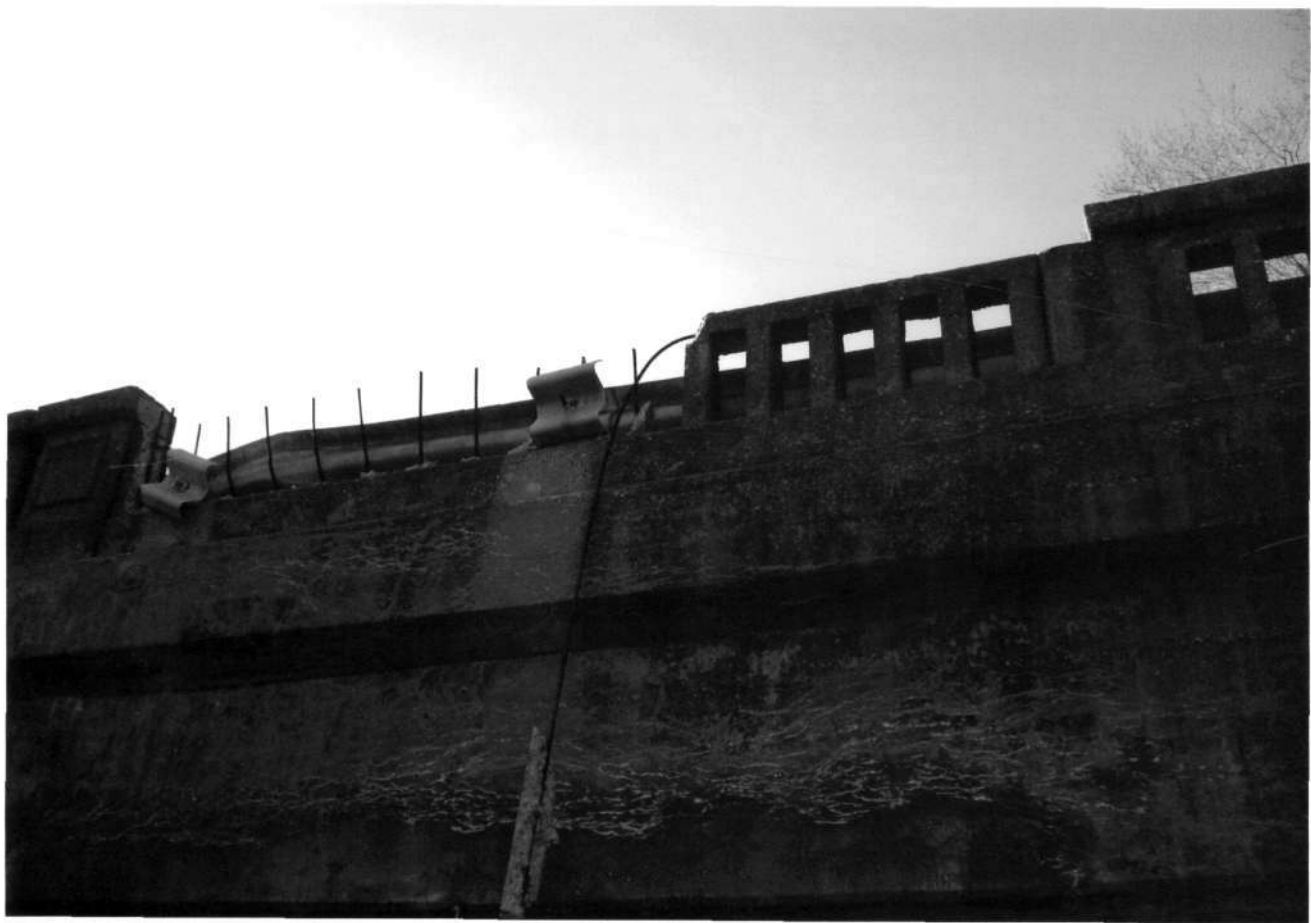
#2 of 6

Ext of SE parapet on WB bridge showing damaged & missing parapet + cracking + efflorescence on face, facing NW

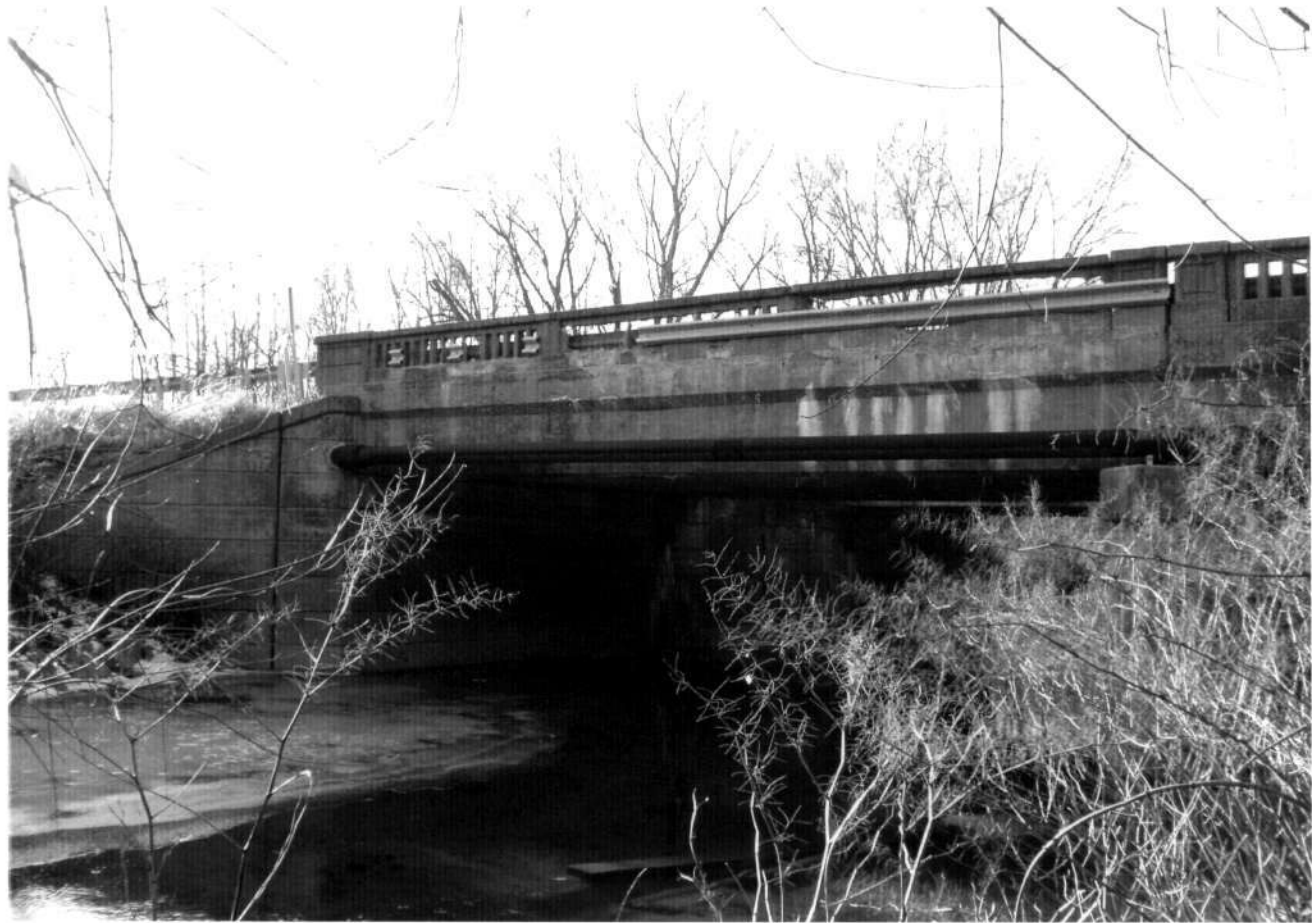
3 of 6

SOUTH EASTERN ELEVATION, FACING SOUTHWEST

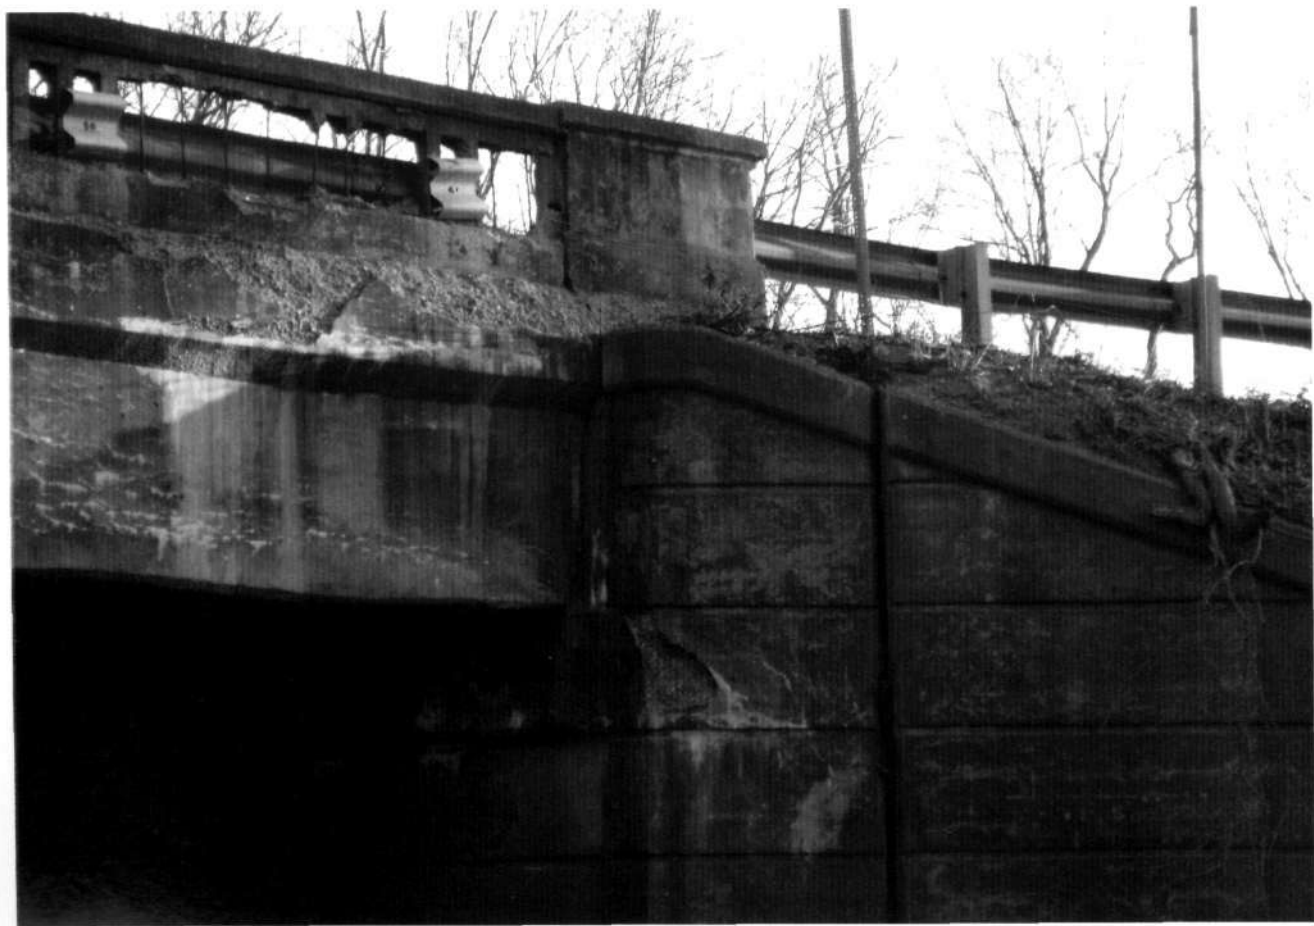
#4 of 6

The current condition rating for the substructure is 6. Field survey has confirmed that the wingwalls exhibit a spall on the northwestern wingwall and a spall on the southwestern wingwall near the joint with the abutment. The pier nose has a metal angle on the northern end that is in good condition but has rusted.

SOUTHWEST WINGWALL & CONTINUOUS ABUTMENT,
SHOWING SPALLED CONCRETE CURB & FASCIA AND
CRACKED WINGWALL, FACING SOUTH.

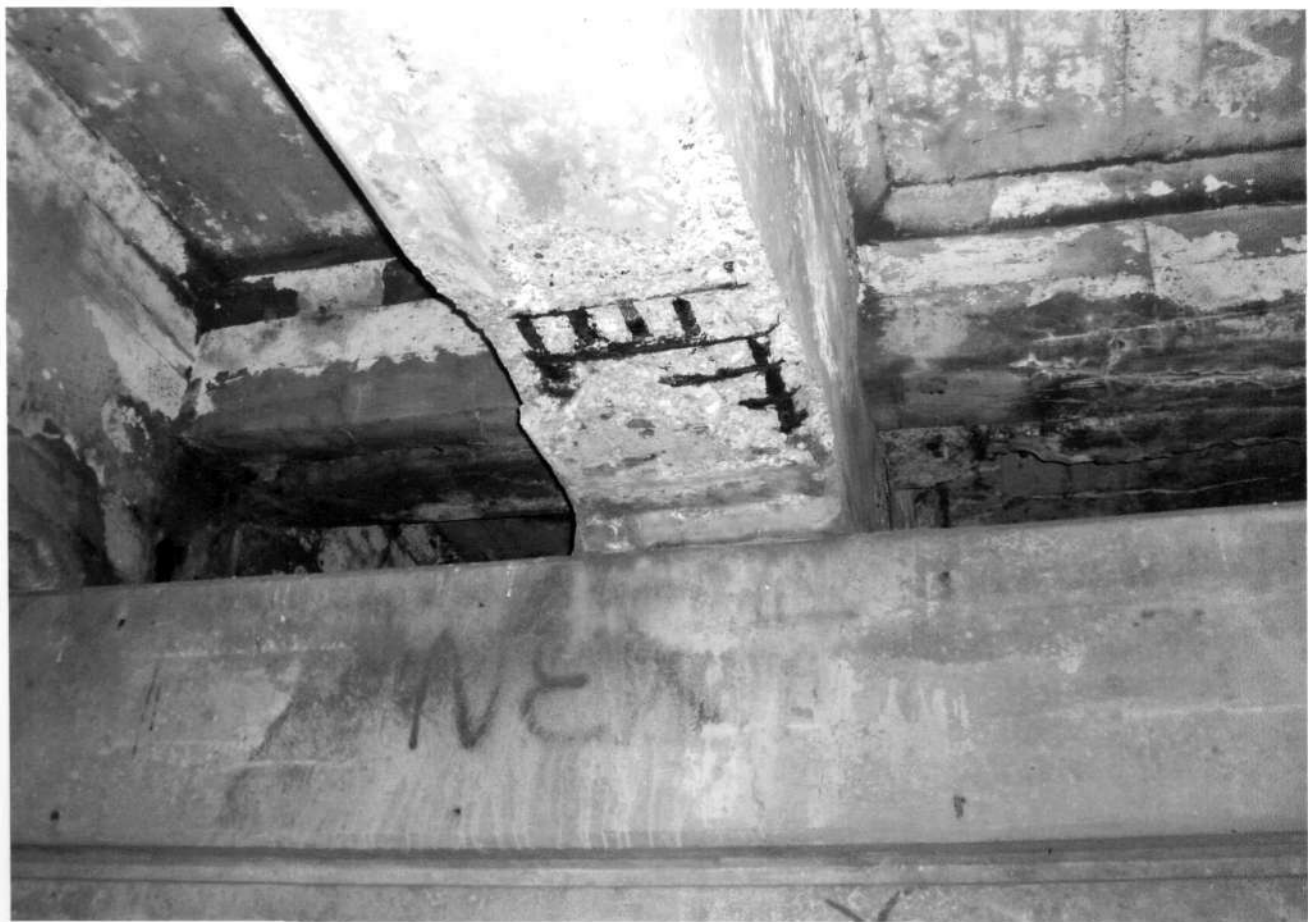
A 5 of 6

The Bridge Sufficiency Rating (BSR) is 62. The current condition rating for the superstructure is 5. Field survey has shown that the superstructure's girders have exhibited deterioration. The bottom of the exterior concrete encased girders has been patched with gunite and has cracks with efflorescence and patched areas. Both exterior girders have heavy scaling and deterioration full height on both sides of the girder at the joint over the pier. Several ends of rebar are exposed as well. Scattered small spots of spall were apparent on the bottom of the girders and deck, and numerous patched areas were visible on the underside of the deck and beams. A large area of exposed rusted rebar was visible on the bottom of a girder on the eastern bay.

EXPOSED REBAR ON UNDERSIDE OF GIRDER,
FACING NORTHEAST (EASTBOUND BRIDGE)

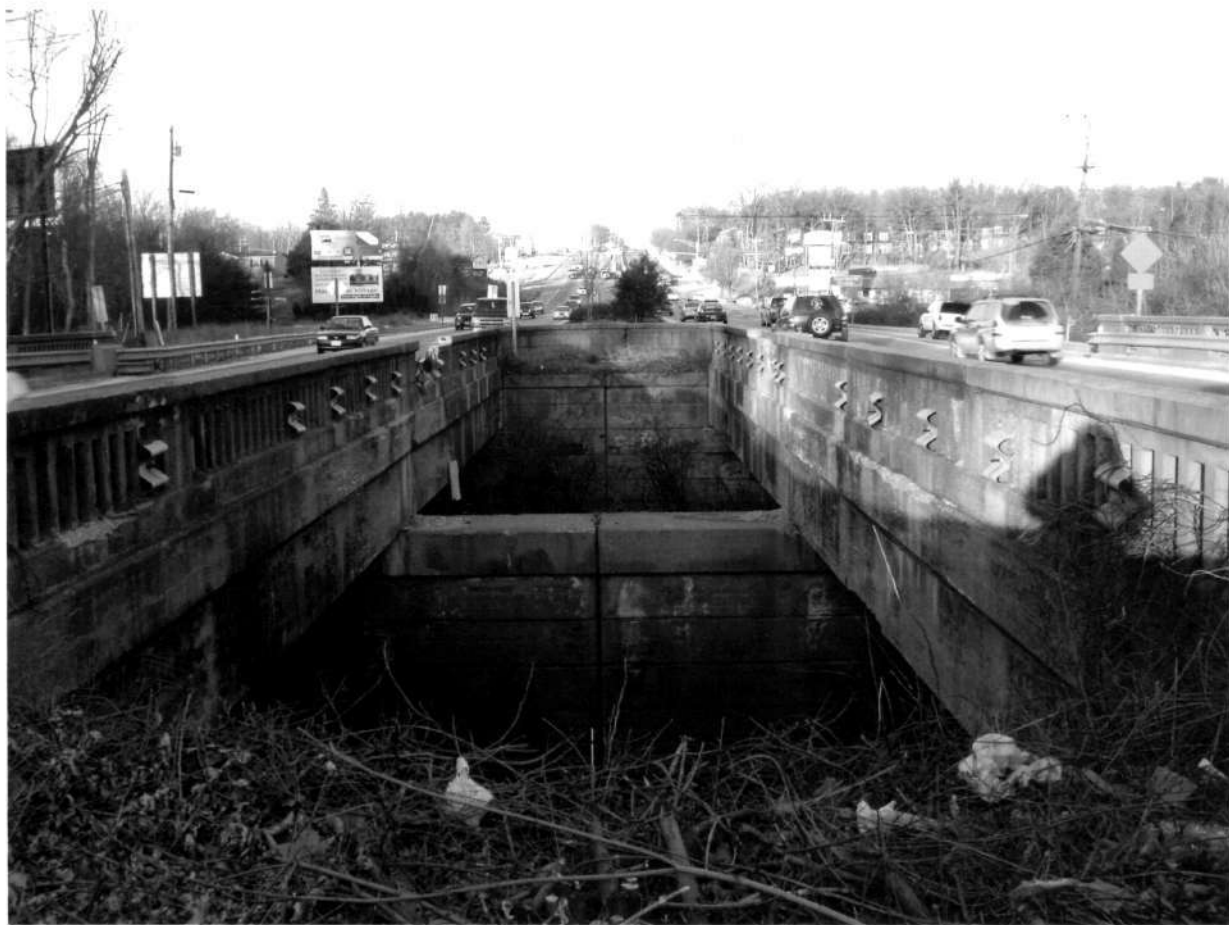
6 OF 6

AREA BETWEEN EASTBOUND & WESTBOUND BRIDGE,
FACING EAST
